**GEOMORPHIC, HYDROLOGIC AND ECOLOGICAL  
EFFECTS OF THE BEAR CREEK MEADOW  
RESTORATION PROJECT: A LAYMAN'S REVIEW**

**PREPARED BY:  
CHRISTOPHER T. HAMMERSMARK  
&  
JEFFREY F. MOUNT**

**NOVEMBER 15, 2005**

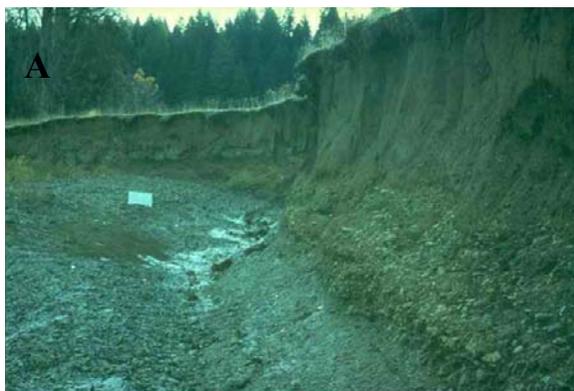
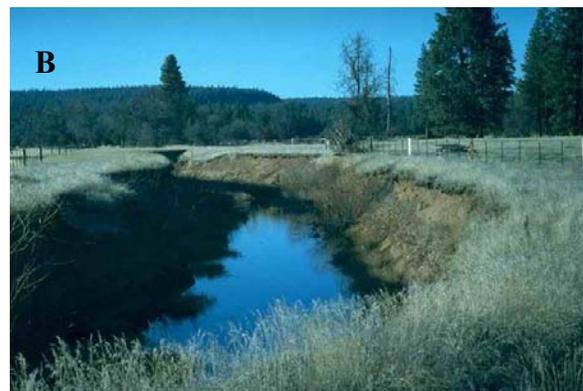
**Figure 2** – **A)** Tall, near vertical unvegetated banks of the pre-restored Bear Creek channel. **B)** Prior to restoration, Bear Creek was best described as a gully (Photos: Rick Poore).

As the stream channel incised and lowered the ground water table, the stream banks progressively grew very tall and steep, and unable to support much vegetation which lead to increased instability of the stream banks (Figure 2). This instability initiated a cycle of lateral erosion of the banks, widening the channel. This lateral channel enlargement confined more water within the channel and contributed even more sediment to the Fall River. Bear Creek’s once numerous shallow, vegetated, and meandering channels had degraded into what are best described as two unstable, erosive gullies (Figure 2).
